# Water Damage Prevention

Water damage is the second most common insurance claim. Here's how to prevent it.

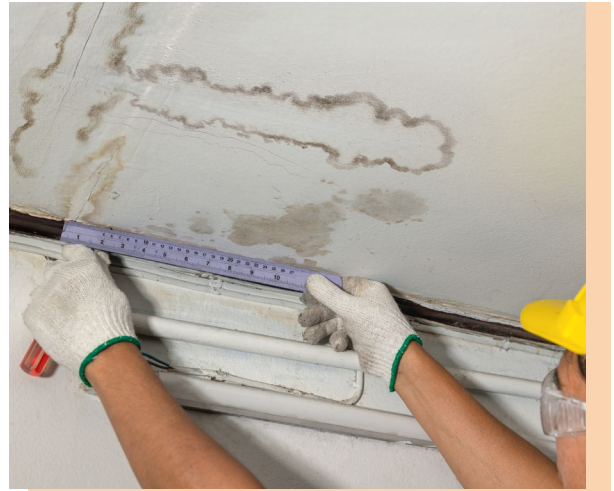
In air conditioning units, which remove humidity from the air and turn it into water, drip lines move the water from the drain pan, where it collects, down the drip line and away from the unit, usually discharging it outside. If the drip line becomes clogged, water can overflow and damage the unit or the building. Clogs, which form when water combines with dust, dirt, and other debris, typically result from poor maintenance, lack of an appropriate drain slope, or an environmental issue such as flooding. Over time, the buildup thickens and can obstruct the line.

**SUGGESTED PREVENTATIVE MEASURES:** Schedule regular inspections of your air conditioning units to identify potential leaks and moisture issues before they become problematic. Typical signs of a clogged drain include a non-working A/C unit, standing water, a foul smell, a full drain pan, water damage, or, in the case of newer units, a notification from the equipment's technology. If you need guidance on developing a maintenance program for your HVAC equipment, ask an HVAC professional or your equipment manufacturer for help.

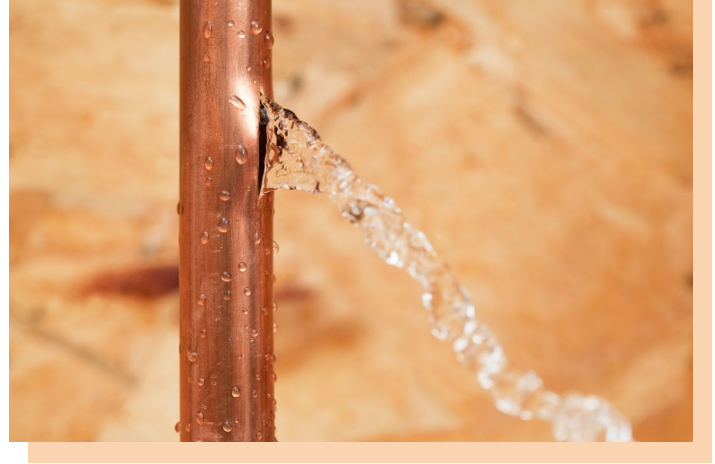
Copper is the standard pipe used in plumbing projects due to its integrity, durability, and high thermal rating, among other benefits. It tends to cost significantly more than other lines, though, and it cannot withstand acidic water, so a city water supply is essential.
